US Army Corps
of Engineers
Construction Engineering
Research Laboratories

USACERL Technical Report 98/09
January 1998

Laboratory Investigation of Selected Sensors for Use With Passive Roof Leak Detection Systems

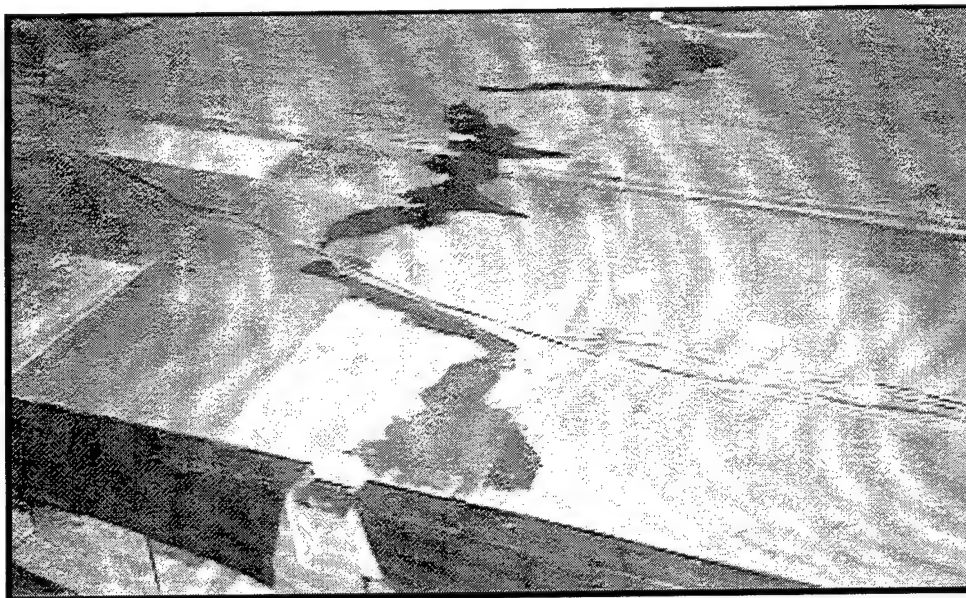
Figure 28. Evidence of water accumulation between membrane and perlite board observed during disassembly of test setup.

After completion of each test, the researchers carefully removed the membrane and insulation layers to investigate and record the areas of water accumulation between component layers (Figure 28).
